HOME INSPECTION REPORT

3919 N Passionate Pt, Beverly Hills , FL 34442
Inspection prepared for: Dave Taylor
Date of Inspection: 11/16/2016
Age of Home: 27 yrs Size: 2393 Sq ft under roof

Home in Perspective

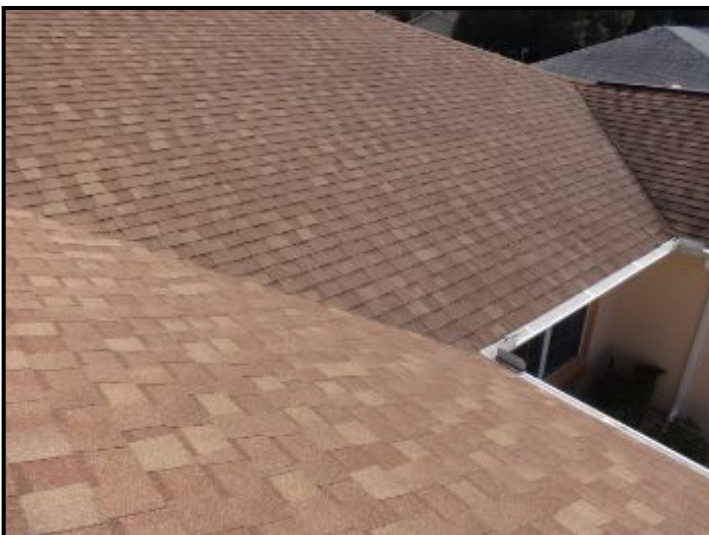
Front view of roof.

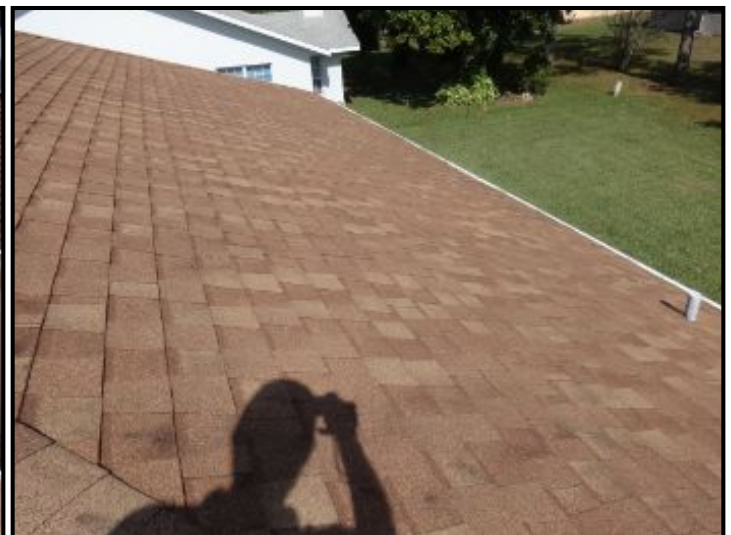
View of backside roof.

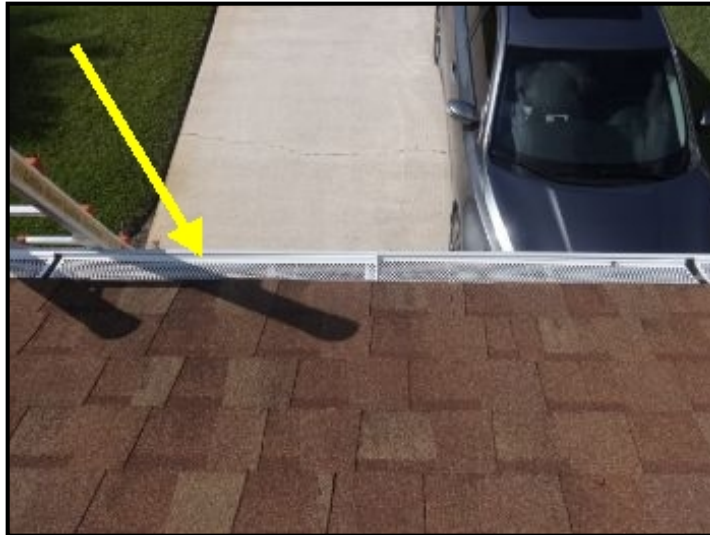
These are very good gutter covers.

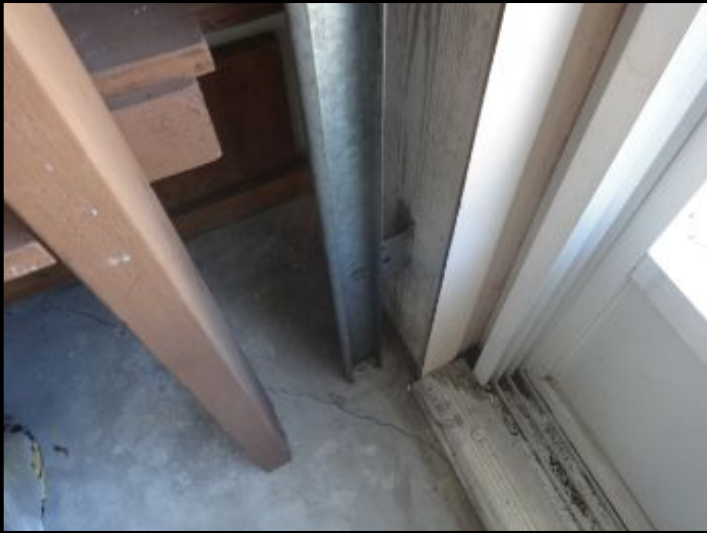
Satisfactory.
There is no safety reverse on the garage door.

There is no safety reverse on the garage door.

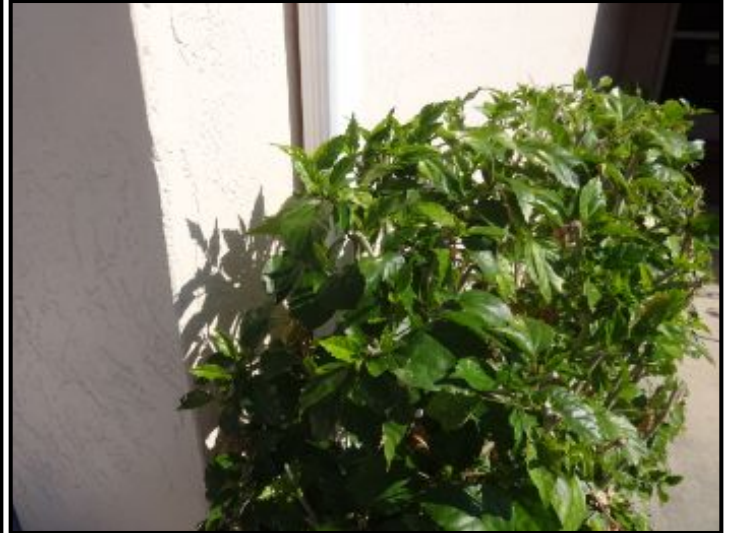
Vegetation up against the home, recommend trimming back some.

Prune or remove any plants that are in contact or proximity to home to eliminate pathways of wood destroying insects.

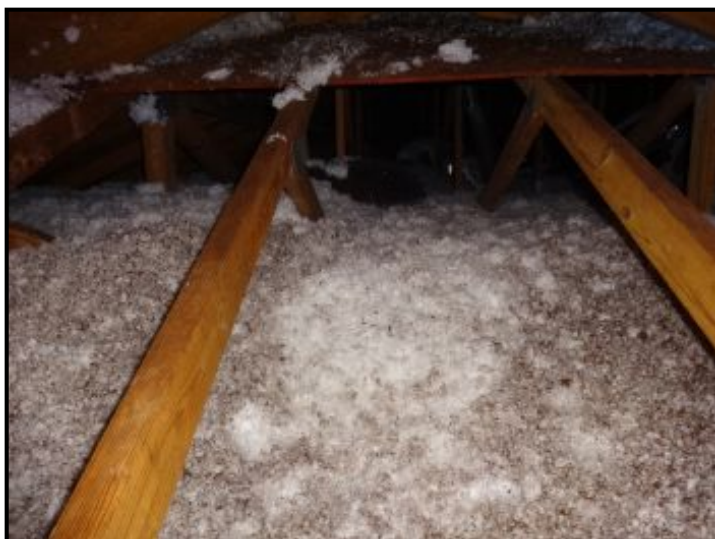
Blown/loose insulation.
Depth average greater than 10 to 14 inches, R30.

Loose insulation depth measurement, over 10 inch average, R 30.

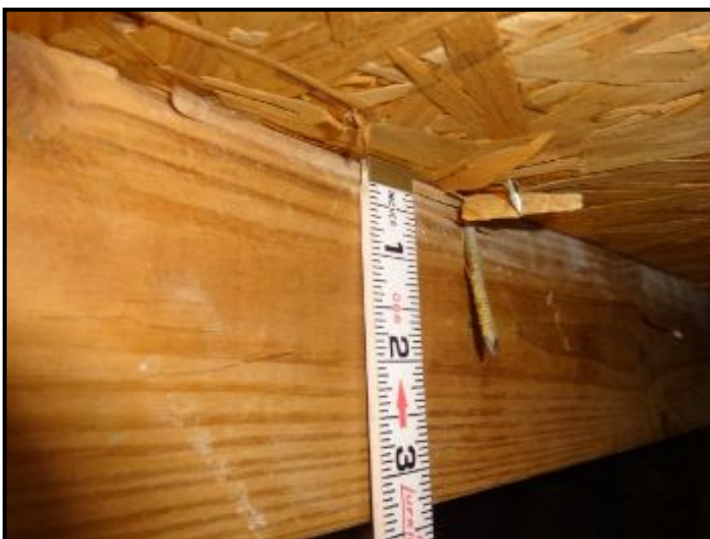
Hurricane nailing in the attic, good for Wind Mitigation deduction on Homeowner's.

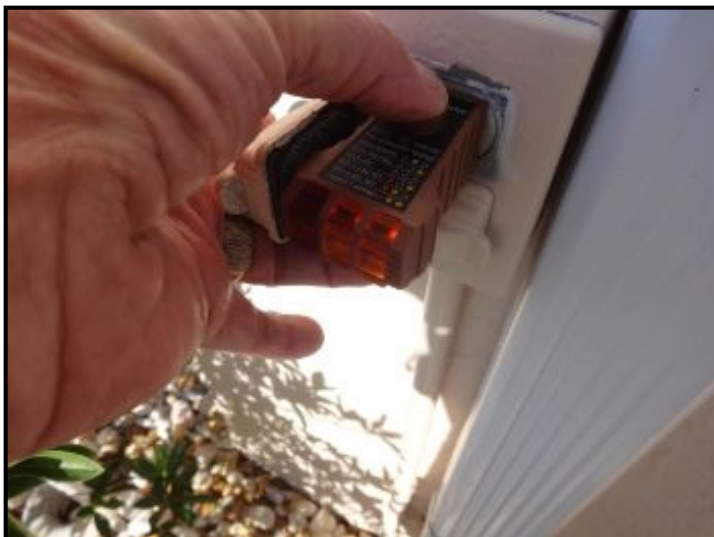
There is no GFI protection on the exterior of this home.

Non-GFCI protected interior or exterior electrical outlets can be upgraded to GFCI outlets for improved safety.

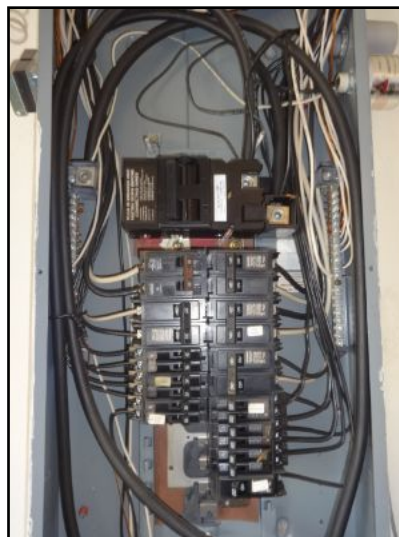
150 Amp service, Challenger electrical panel with cover off.

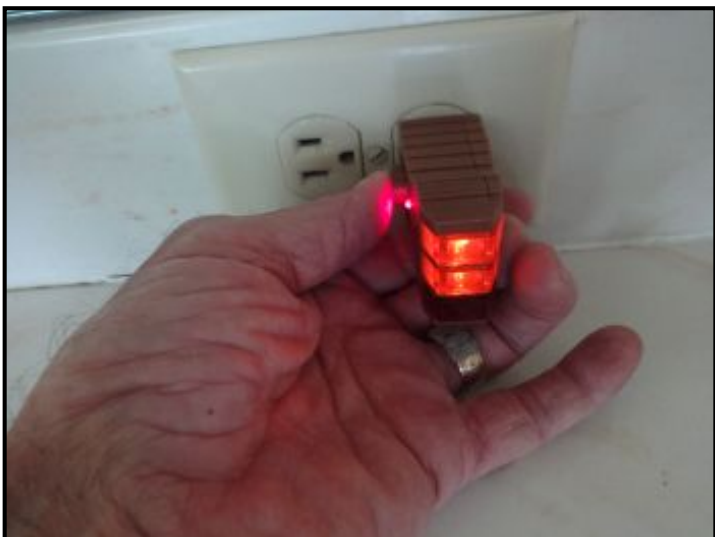
There is no GFI protection in the bathrooms of this home.

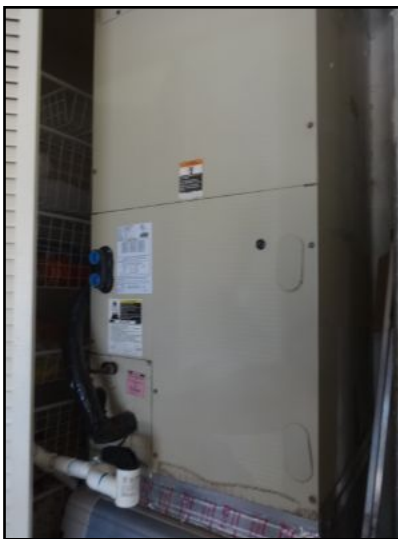
Air handler, Carrier, model from 2001

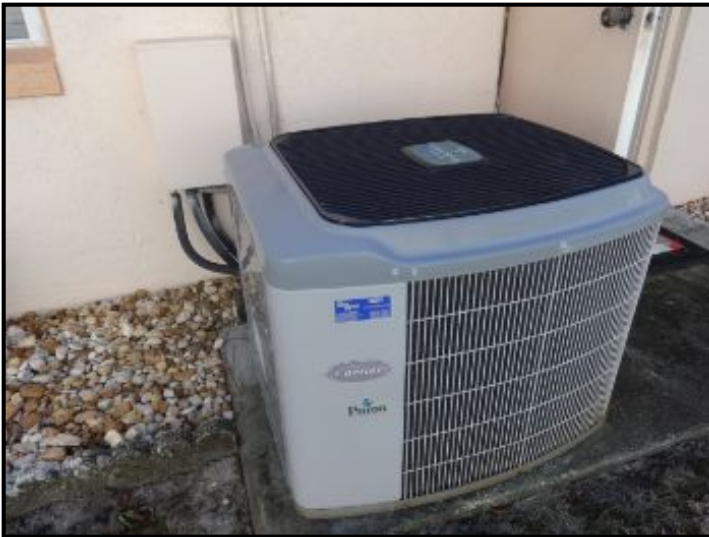
A/C unit, Carrier, model from 2000.

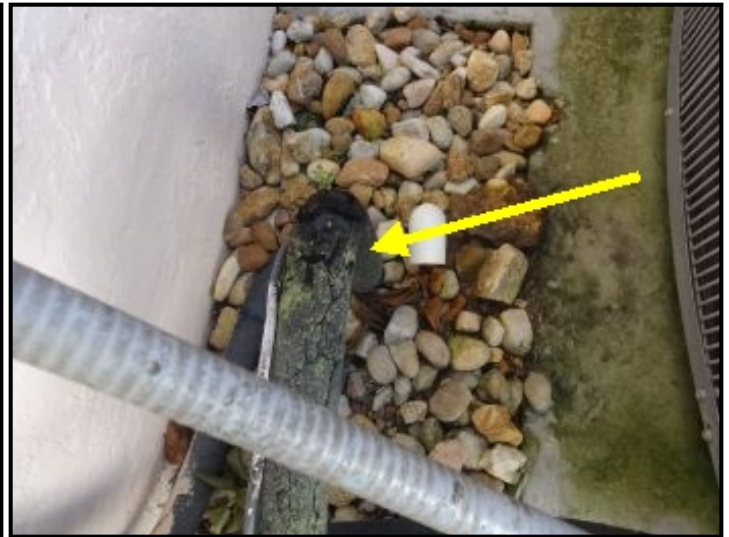
Exterior coolant line, weathered insulation, recommend replacement.

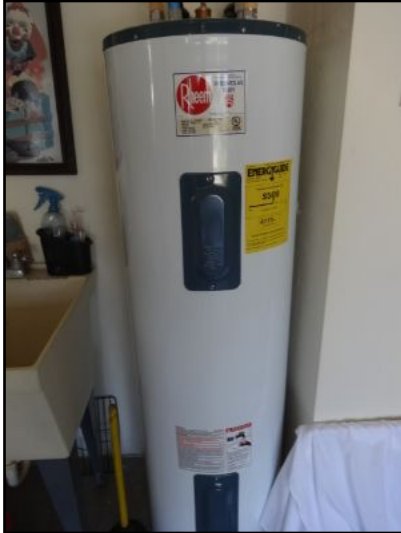
Rheem water heater, 40 gal, model year 2010.

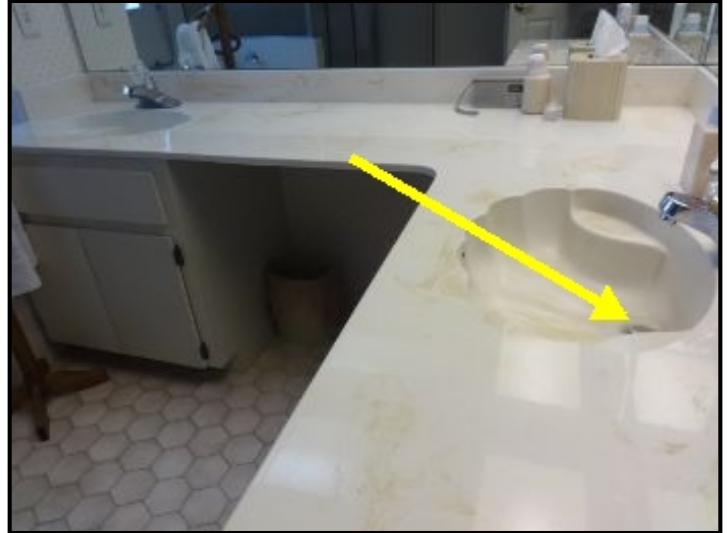
The right master bath sink stopper does not hold water in the sink.

In the master bathroom, the sink stopper in the right sink does not hold water.

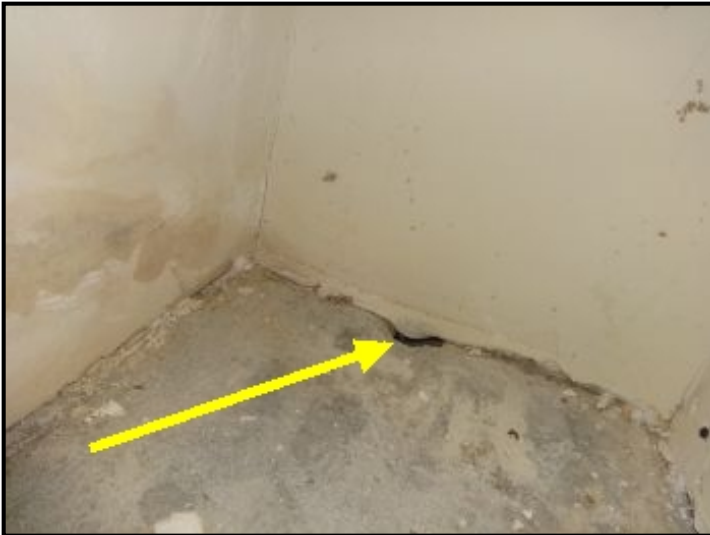
In the low cabinet in the northeast bedroom, this hole in the slab was noticed by the pest guys.

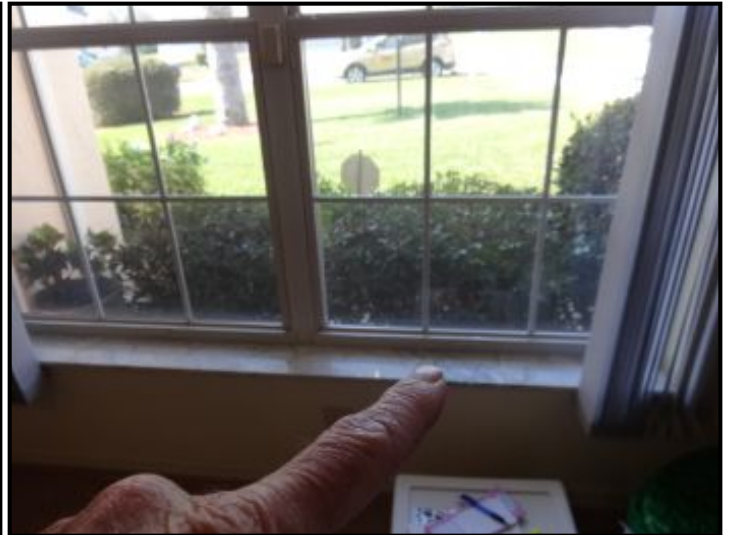
There are two windows that have cracked plastic on the bottom sections, and issues with the latch for cleaning. See photos.

There are two windows with broken plastic on them. This one is the right front window, in the living area.

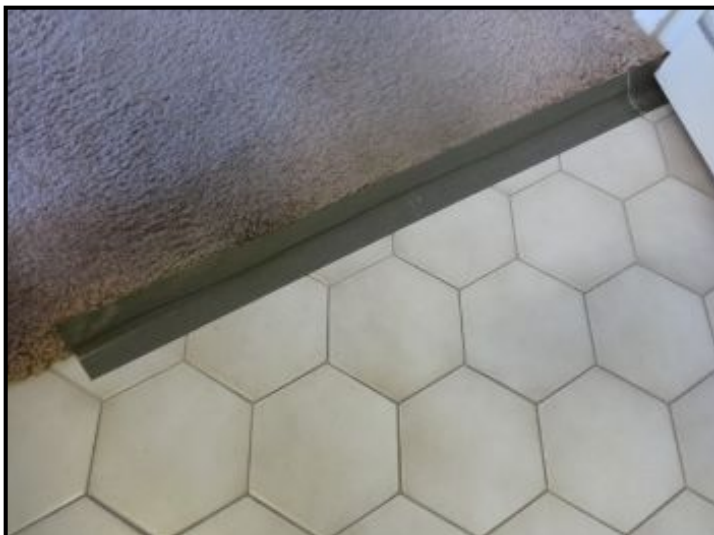
Tape used as a transition from the master bath to the bedroom.

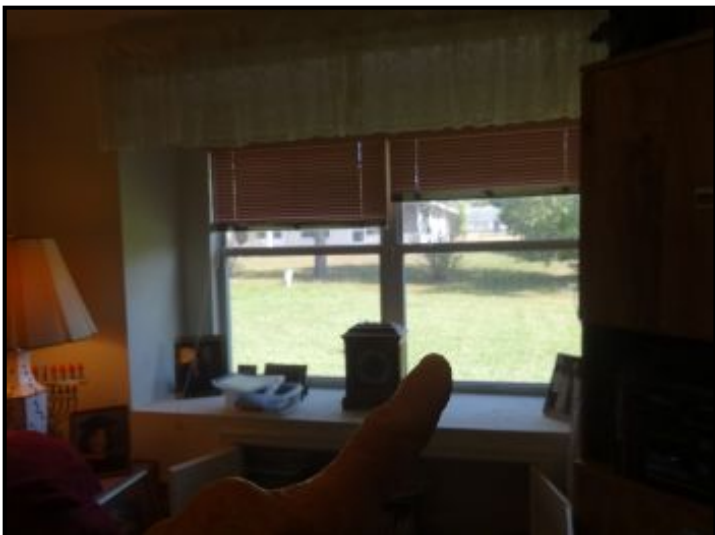
The right window in the northeast bedroom is difficult to raise and the opening latch on the top of the bottom section is damaged.

In the northeast bedroom, this window on the right was difficult to open. The clip on the upper left that allows the window to tip forward for washing is also broken.

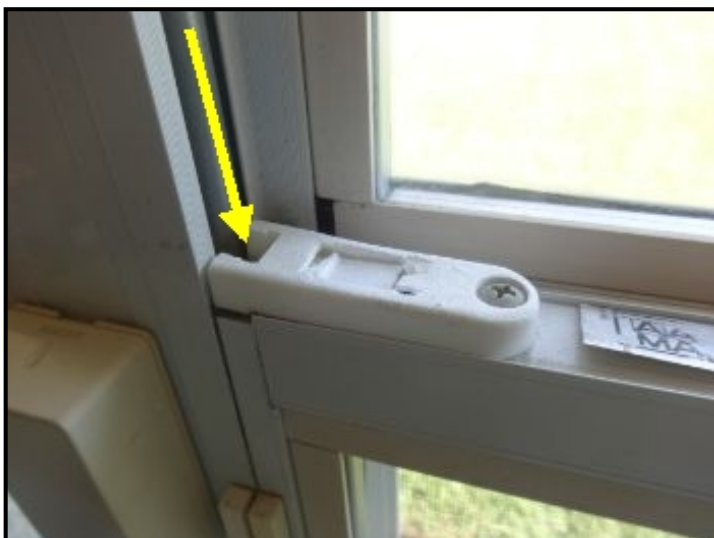
The broken clip from the previous window photo.

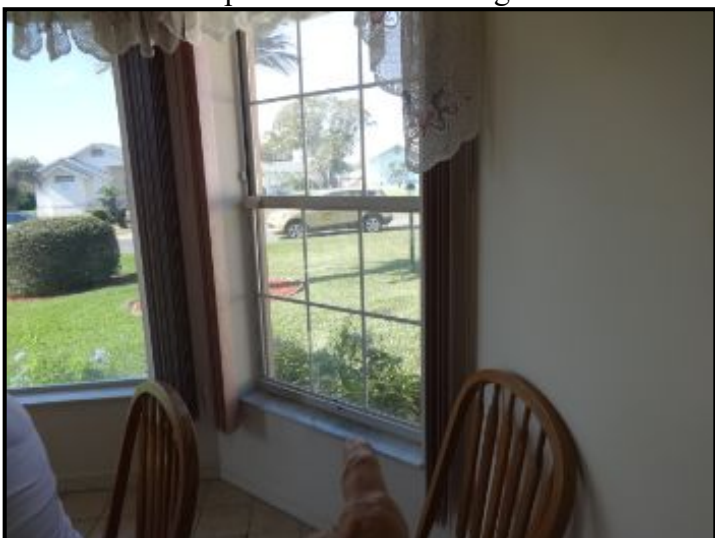
The breakfast nook window plastic is cracked here.

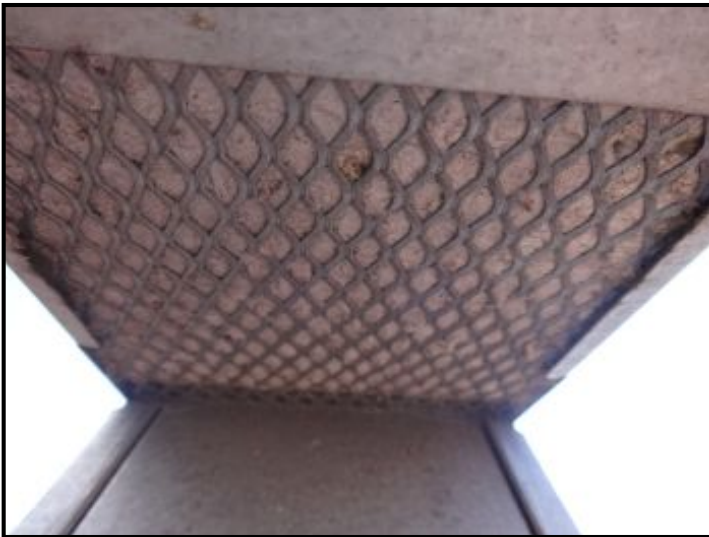
View of dryer vent on the roof. Recommend cleaning.

The dryer vent pipe goes through the attic and out the roof. Recommend cleaning the vent out at least once annually, or when the dryer begins to take too long to dry efficiently.

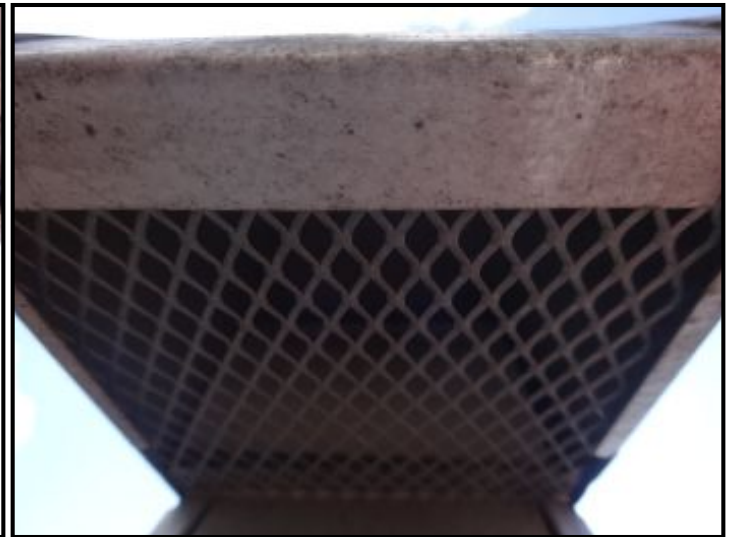
While this is to the bathroom vent, this is what the previous dryer vent should look like for better efficiency.
