# HOME INSPECTION REPORT

5555 Anywhere St., Hernando, FL 34442 Inspection prepared for: Any Name Date of Inspection: 1/14/2023 Age of Home: 2001

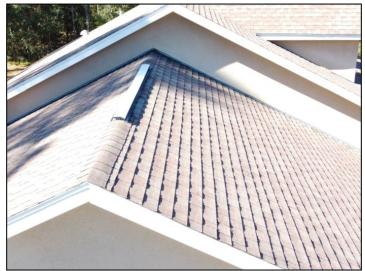
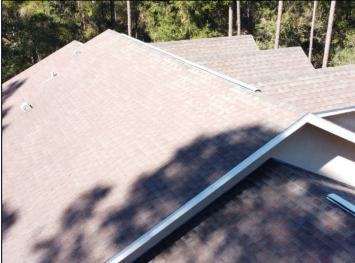
Overall views of the roof. Original to the home. 23 years old.

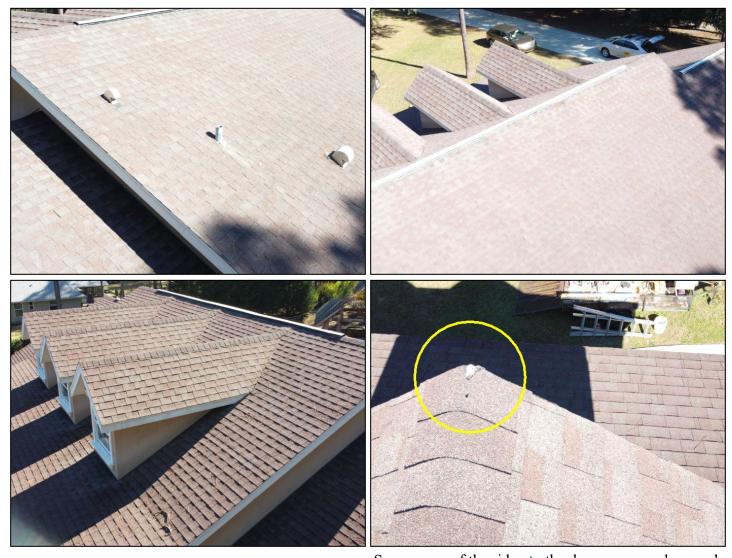
Some areas of the ridge to the dormers were damaged.

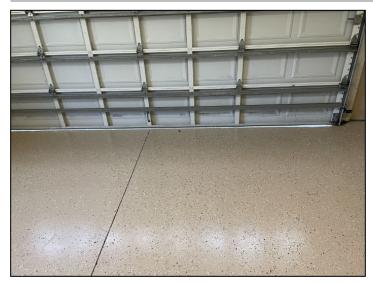
The garage door did not seal all the way when closed, needs adjustment.

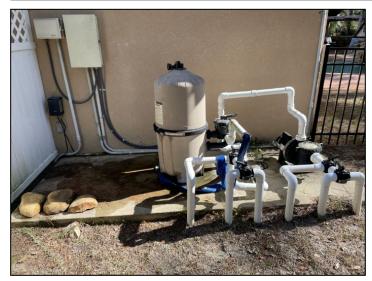
Pool filter, pump. The system was running and electrically bonded as required.

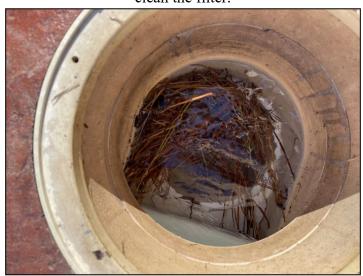
Skimmer was full of debris.

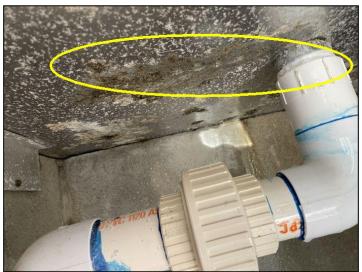
Several areas had water coming down and filling up the bottom of the enclosure. Recommend a licensed contractor for evaluation and repair as needed.

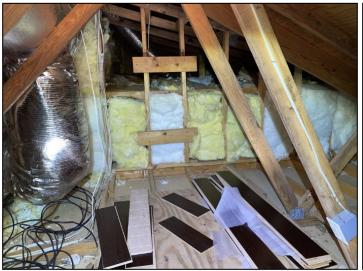
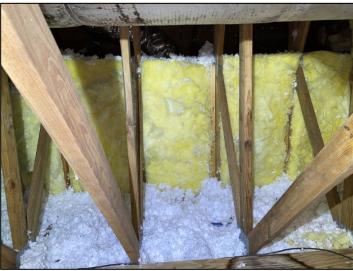
It is difficult to get around to all areas of the attic due to the roof truss construction. Areas that could be visually inspected looked satisfactory.

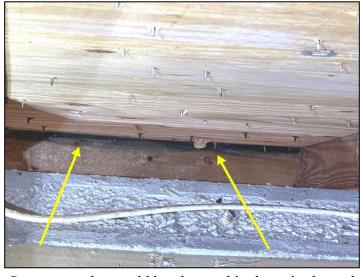
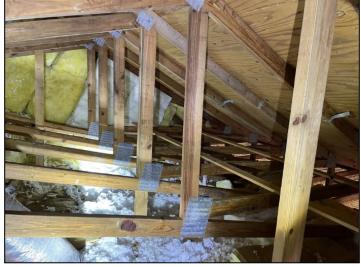
Evidence of past or present leaks, dry at time of the inspection. Monitor for leaks &/or have roofing contractor evaluate.

Some areas that could be observed in the attic showed small signs of water intrusion at the ends of the roof, behind the fascia. This typically happens with roofs as they age.

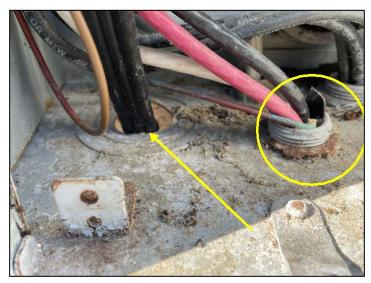
Recommend sealing points of entry in the outside electrical panel to keep pests out. Also, recommend inserting a protective ring in this knockout in order to protect the wiring from damage (such as the one circled to the right).

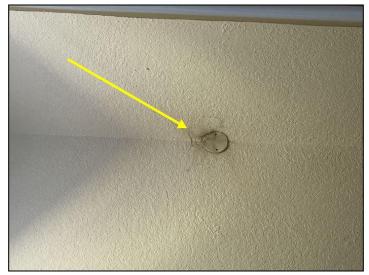
Discoloration was observed at this cover plate location Red dot in the center is the hot spot from the previous in the foyer. Could not see check if it was moisture, dirt, or possible electrical.

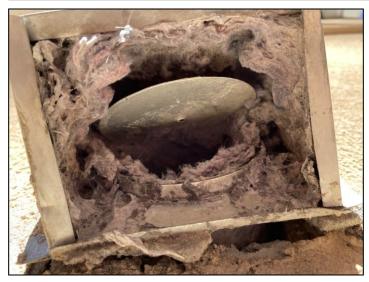
View of dryer vent coming out of the back of the house. Recommend cleaning.
