4-Point Inspection Form

Anywere Cir. Ocala, FL. 34476
Inspection Prepared For: Any Name
Date of Inspection: 1/16/2023

Actual Year Built: 1997 _____

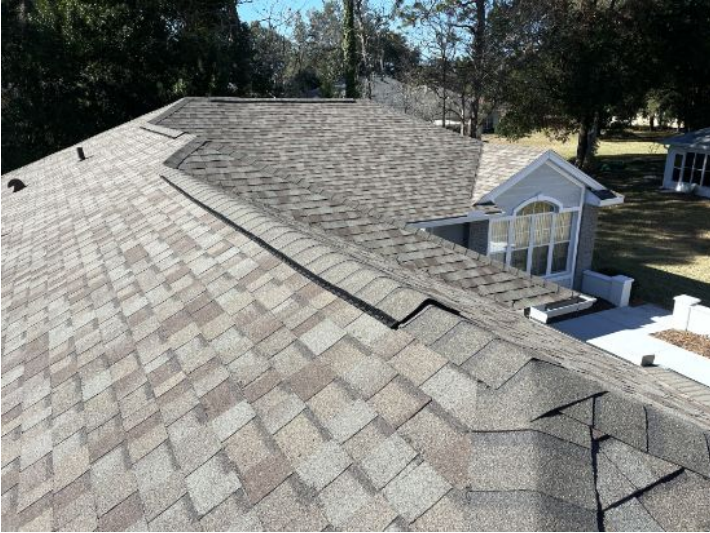
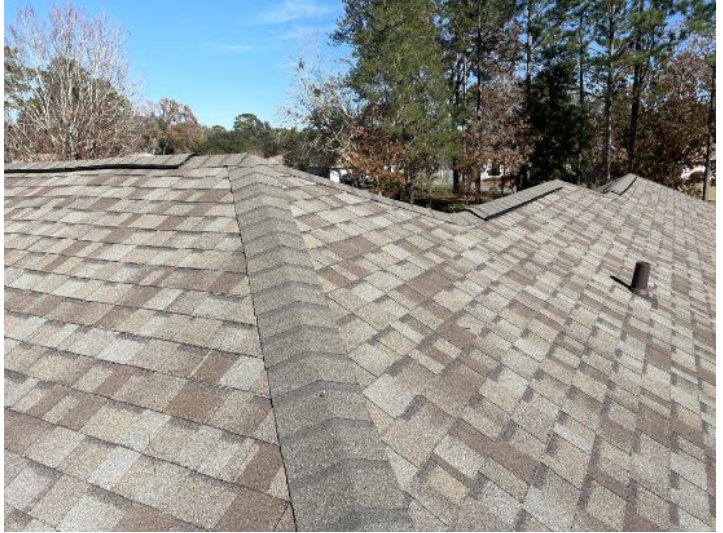
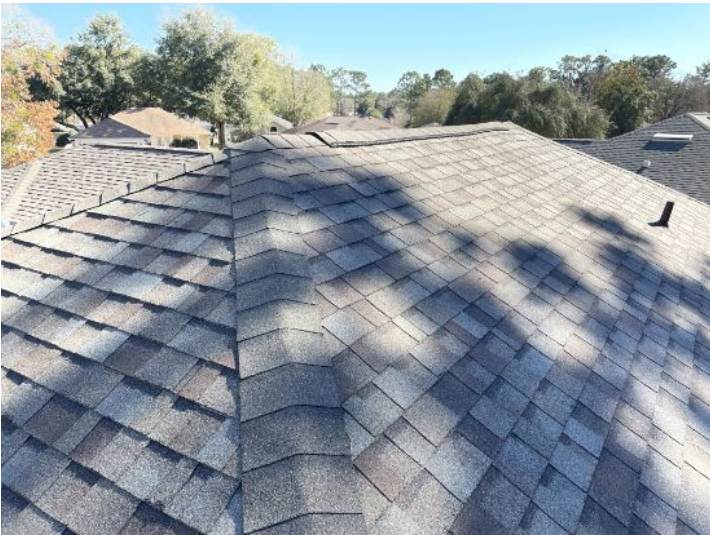
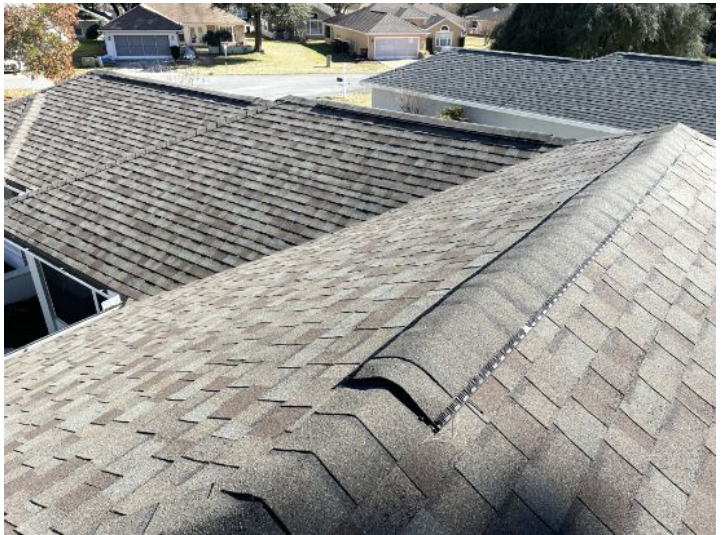
- Covering material: Asphalt shingles
- Roof age (in years): 3 years
- Remaining useful life (years): 17 years
- Date of last roofing permit: 2020

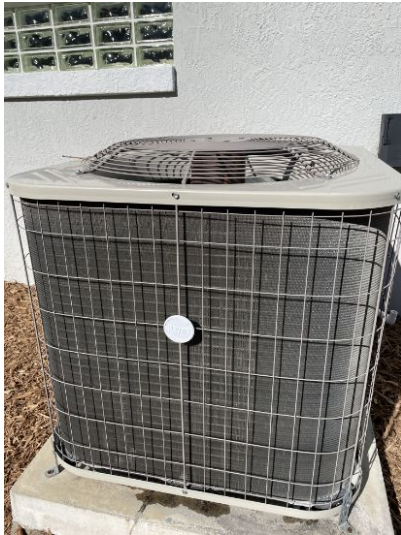
A/C condenser 2020

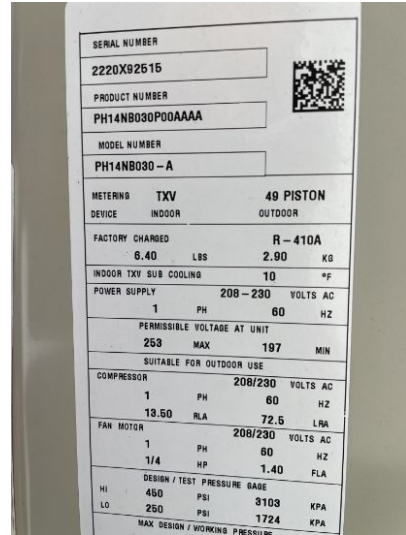
A/C label

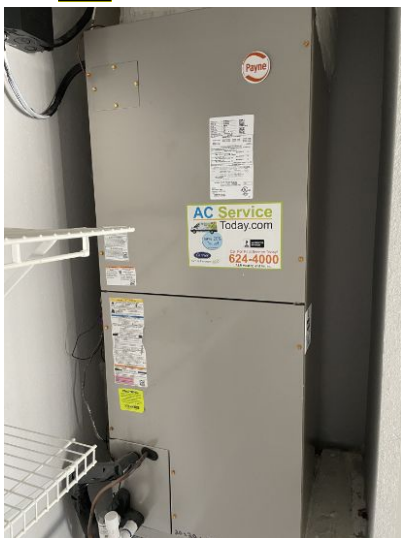
Air handler 2020

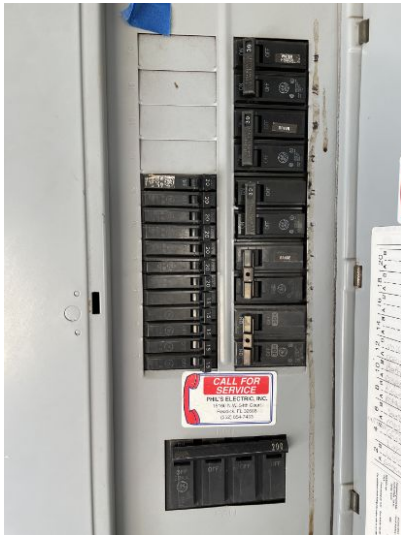
200 amp GE electrical panel

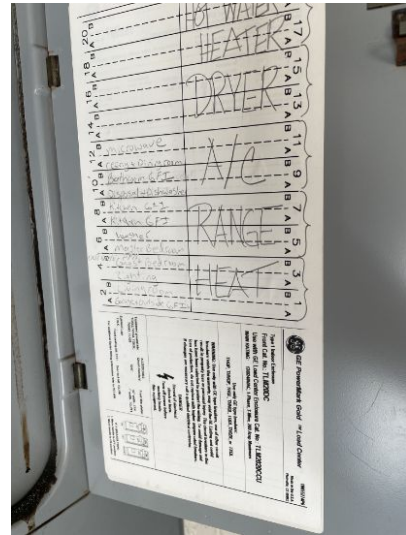
Electric panel label

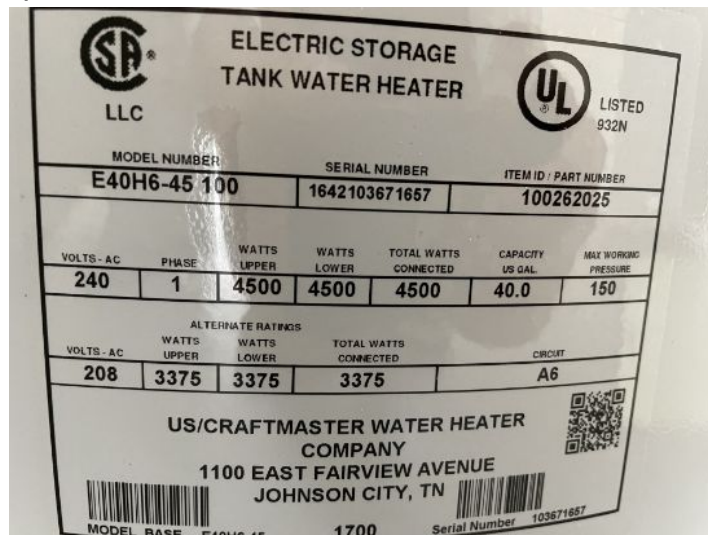
Water heater label
